**LANDING GEAR - BRAKE CONTROL UNIT (BCU PN 90005034-8) - REPLACEMENT FOR AIRCRAFT
EQUIPPED WITH BCU-7 (BCU PN 90005034-7)**

This service bulletin supersedes the SB500-32-0016.

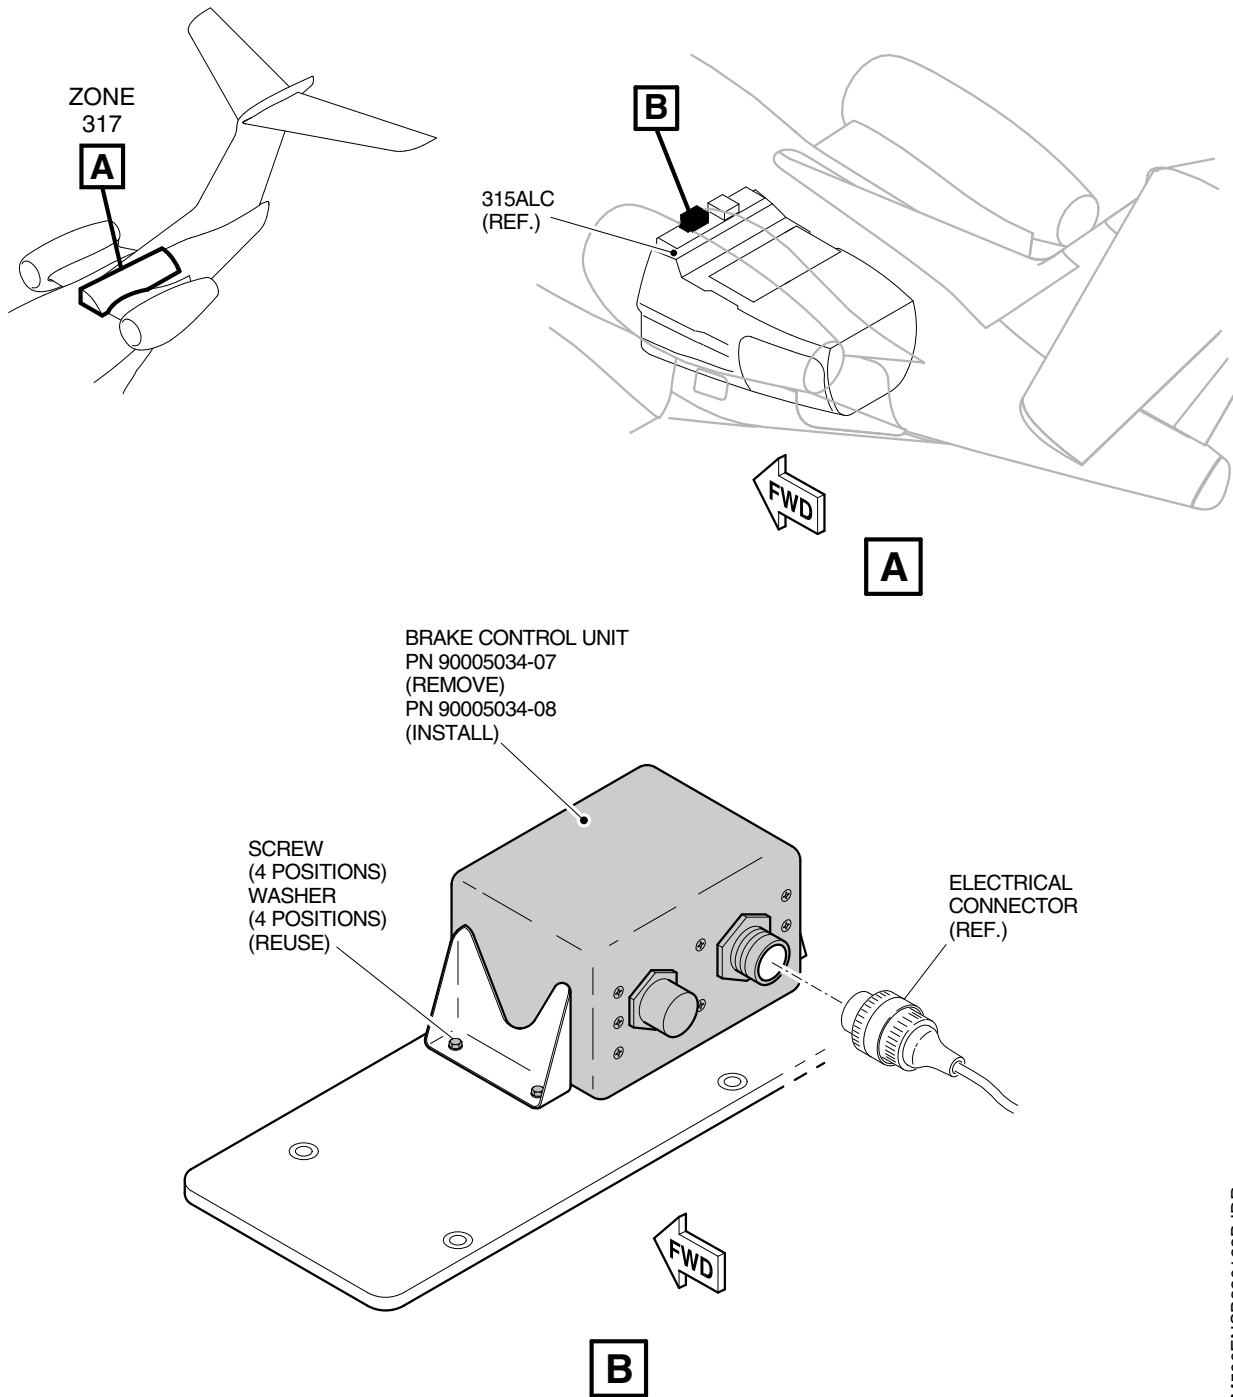
FIGURE 1 - BRAKE CONTROL UNIT (BCU) - REPLACEMENT
(Sheet 1 of 1)

EMBRAER has received reports of perceived low-braking performance during landings with airplanes equipped with BCU-7. Flight Data Recorder (FDR) analysis has shown that the hydraulic pressure measured in one of the brake assemblies was lower than expected during the landing run, leading to an unannounced asymmetrical loss of normal brake system.

This bulletin consists of the replacement of the Brake Control Unit PN 90005034-7 with a new improved one bearing PN 90005034-8, which has an updated software.

To gain access to the work area, it is necessary to remove aft baggage compartment ceiling panel 315ALC.
