SB No.: 500-21-0001 PAGE: 1 of 1

AIR CONDITIONING - REPLACEMENT OF THE FLOW CONTROL SHUTOFF VALVE (FCSOV)

DATE: 09/Dec/2009 REVISION No.: 01 - 20/Nov/2012

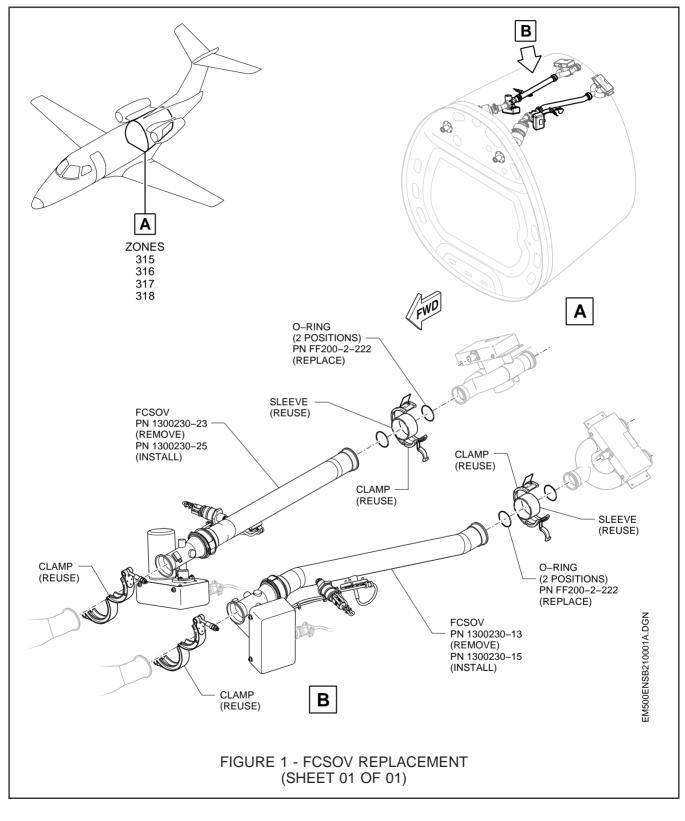
Instances have been reported concerning the failure of the Flow Control Shutoff Valve (FCSOV) in the closed position. Failure of the two valves (left and right) can cause the loss of the pneumatic source, and lead to loss of the cabin pressurization.

- A. Make sure that the aircraft is safe for maintenance (AMM TASK 20-00-00-910-801-A/200 Aircraft Maintenance Safety Procedures).
- B. Remove the ceiling panel 315 ALC and 316ARC according to AMM TASK 50-31-02-000-801-A/400 - Aft Baggage-Compartment Ceiling Panel - Removal.
- C. Remove the valves PN 1300230-13 and PN 1300230-23 as given in AMM TASK 21-21-01-000-801-A/400 Flow Control Shutoff Valve (FCSOV) Removal. Refer to Figure 1.

- D. Install the new valves PN 1300230-15 and PN 1300230-25 as given in AMM TASK 21-21-01-400-801-A/400 Flow Control Shutoff Valve (FCSOV) Installation, with its attachment parts saved during the removal procedure. Refer to Figure 1.
- E. Install the ceiling panel 315 ALC and 316ARC according to AMM TASK 50-31-02-400-801-A/400 - Aft Baggage-Compartment Ceiling Panel - Installation.
- F. Restore the aircraft to normal.
- G. Enter the accomplishment of this bulletin in the applicable documents.
- H. Download and fill out the "Service Bulletin Implementation and Evaluation" form in Portable Document Format (PDF) from the Flyembraer portal (<u>http://www.flyembraer.com</u>) or fill out the attached form and send it to address below:

NOTE: Send the removed FCSOV to Embraer, as per address in 2.C. MATERIAL NECESSARY FOR EACH AIRCRAFT.
